Late Transverse Patellar fracture following patellar tendon reconstruction using semitendinosus graft via single transverse tunnel

Abstract

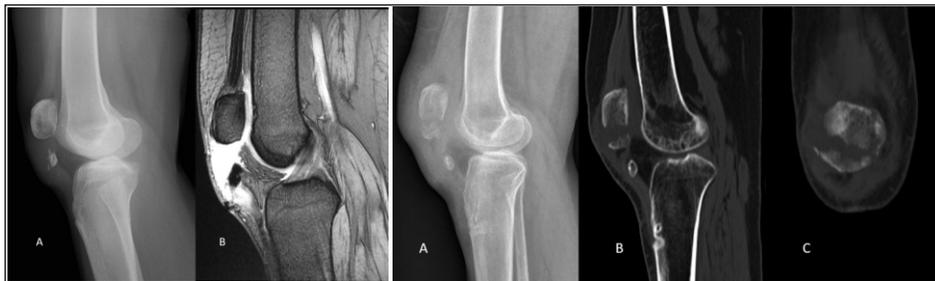
Figure 1: 1A, proximal migration of patella after patella tendon rupture. 1B; 2B,C; CT scan showing transverse fracture patella MRI showing ruptured patella tendon. through the tunnel.

A twenty nine-year-old female, presented to our Knee clinic with chief complaint of pain in right knee and difficulty in climbing stairs following a direct open trauma to the knee three months back. She had pain, swelling and an open wound over the knee, and was unable to walk. She visited a general surgical clinic where the laceration was sutured under local anaesthesia and medications were prescribed. However, she continued to walk with limp and pain for next three months. Clinical examination revealed high riding patella with a healed transverse scar in front of the knee. Further, a gap was felt inferior to patella over the patellar tendon area. There was extensor lag of 40°. The knee range of movement was 0-140°. Rest of the examination was normal. A clinical diagnosis of neglected patellar tendon rupture was made. Plain radiographs of knee were taken in Anteroposterior, lateral and axial views (Figure 1A). Magnetic resonance imaging (MRI) of the knee confirmed tear of the patellar tendon with proximal migration of patella with no other intraarticular injuries [figure 1B]. Patellar tendon reconstruction was planned using ipsilateral semitendinosus

operatively, patient sustained a trivial fall, and injured her right knee. Radiological examination revealed transverse fracture of right patella just through the inferior part of bony tunnel in the patella [Figure 2A]. CT scan confirmed the findings [Figure 2B, C]. A week later, the transverse fracture of patella was fixed with a single 4.5 mm cannulated cancellous screw [Synthes, US] augmented with multiple no.2 fibre wire (Arthrex, Naples, FL, USA) via transosseous tunnels drilled in superior and inferior fragments of patella using 2 mm K wire [Figure 3A-C]. The ST graft was found to be intact. Immediate post-operatively, the knee was immobilised in extension brace. At 10th post-operative day, knee was mobilized with a hinged self-adjustable range of movement brace, allowing 0-45° degrees initially to 0-90° degrees in 5 days and patient was discharged. At 3 month follow-up, patient had 0-90° degrees of flexion with quadriceps with grade 4 power. At one year post surgery, patient had no complaints with range of motion 0-90° degrees with quadriceps grade 5, without extensor lag [figure 4]. However, she was not able to perform squatting. Her final

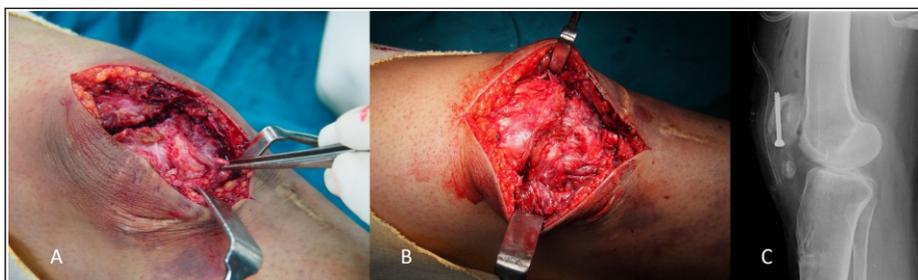
Figure 3: 3A shows fracture patella with forceps holding the intact semitendinosus tendon. 3B shows reconstructed mechanism. 3C shows fracture reduction with 4.5mm cannulated cancellous screw.

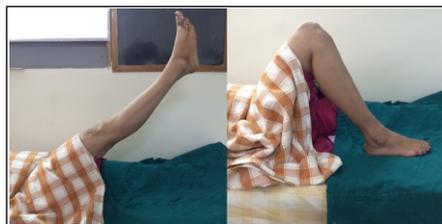
Figure 4: No extensor lag and flexion of 90 degrees.
