Extravasation of Irrigation Fluid to External Genitalia during Knee Arthroscopy: A Case Report

Abstract

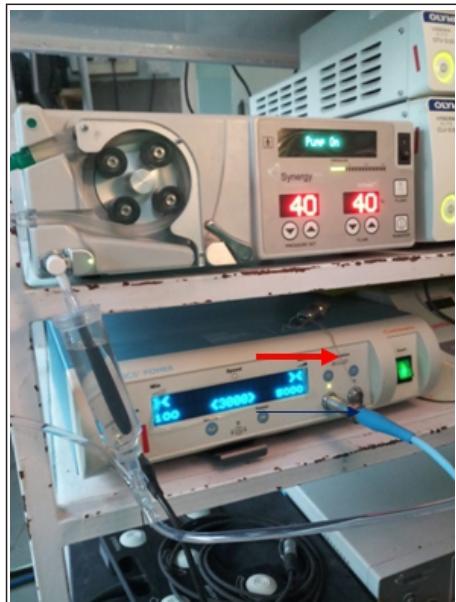
held in a clamp, with a pneumatic tourniquet (pressure, 350 mm Hg) at the top of the leg. However, the tourniquet was not inflated. The pump used was Arthrex Continuous Wave III Arthroscopy Pump (Model Ar6475). The irrigation fluid used was a normal saline isotonic solution with maximum pressure set to 40 mm Hg. Exploration of the joint confirmed the ACL rupture as well as a lateral meniscal tears. It was then noted that the thigh was becoming increasingly edematous and had a woody feel. Immediately, we realized that the arthroscopy pump reservoir that would be normally half-filled was filled to almost full capacity (Fig. 1).

Figure 1: Irrigation pump with faulty sensor. The fluid level in the sensor is above the normal level.

reservoir. We believe the over-filled reservoir led to a dysfunction of the pressure sensor which caused the extravasation. Hence, it is important to look at the fluid level in the reservoir. Also Further more, since the injury was an old one, the presence of a probable capsular tear is also possible. In our case, the lack of pressure control is the predisposing factor to this kind of complication.

The complication can be prevented by the right choice of equipment, correct use of arthroscopy pump, and regular maintenance of the pressure sensors[8,9]. The conservative management with monitoring of the patient for the signs of the compartment syndrome is the treatment of choice in these kinds of complications [10].

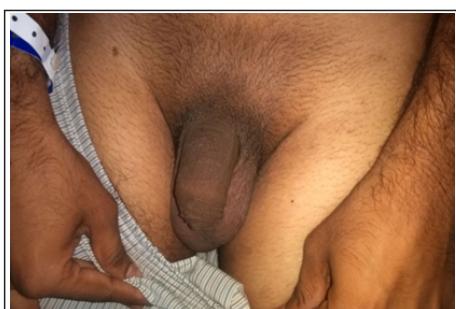
The patient was then monitored for symptoms of compartment syndrome. The patient did not give symptoms suggestive of compartment syndrome. Two days later, the Coban™ and urinary catheter were removed. Oedema had subsided from the penis and thigh, and the patient was able to pass urine normally (Fig. 4).

Figure 4: Postremoval of Coban. Edema has subsided

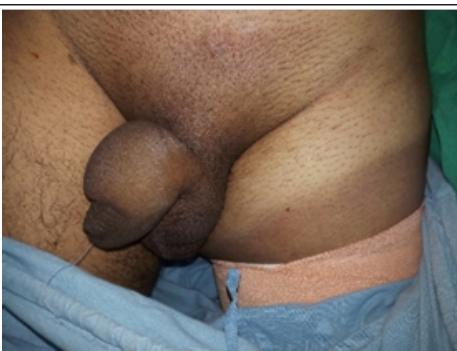
torn and flipped into the intercondylar area. The total duration of the surgery was one and a half hour. After removal of the drapes and tourniquet, swelling of the thigh and external genitalia was noted. (Fig. 2).

Figure 2: Clinical appearance of the infiltration of the thigh, external genitalia, and lower abdomen due to extravasation of irrigation fluid.

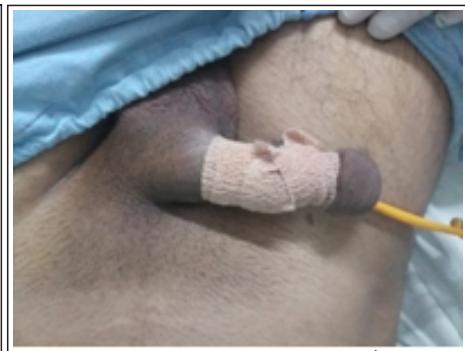
syndrome and pulses (posterior tibial and dorsalis pedis arteries) were all normal. Urology consultation was taken immediately and as suggested by them, catheterization was done along with application self-adherent wrap (3M™ Coban™ Self-Adherent Wrap) to the penis (Fig. 3).

Figure 3: Self-adherent wrap (3M™ Coban™) applied to the penis to reduce the edema.
